# Manhole Inspection Summary

Manhole # **S15QQ\_008MH**

Insp Date: **8/8/07 10:25 AM**

**Location** Address: **3220 TIOGA PARKWAY**

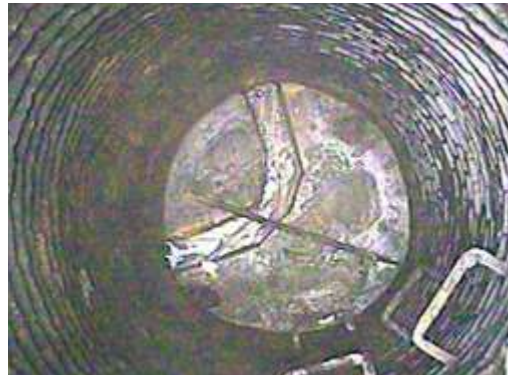
Top View

DEBRIS ON BENCH

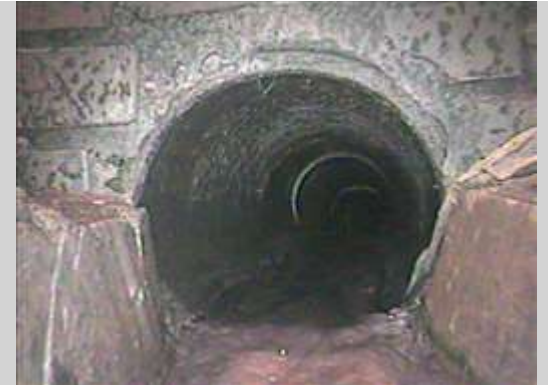
12 O'Clock Outflow

8 in. Circular Gravity Sewer  
Pipe Out @ 12 O'Clock

Invert Depth: **13.18** (ft.) Flow Characteristics: **Fast**

Deposits: ☒ None ☐ Mud ☐ ~~Sludge~~ ☐ **Debris** ☐ Grease

Infiltration: **None** Pipe Seal Cond: **Cracked**

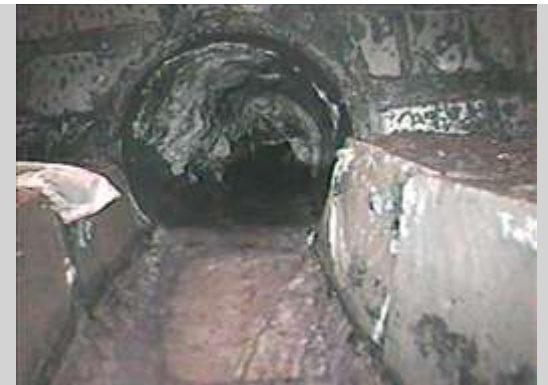
9 O'Clock Inflow

8 in. Circular Gravity Sewer  
Pipe In @ 9 O'Clock

Deposits: ☐ None ☐ Mud ☒ ~~Sludge~~ ☒ **Debris** ☐ Grease

Silt Depth: **1** (in.) Deposits Extent: **Light**

Infiltration: **Evidence** Pipe Seal Cond: **Sound**
